PLANNING AND METHODOLOGY ADOPTED TO DEAL WITH ADVERSE GEOLOGICAL PROBLEMS ENCOUNTERED DURING HRTS EXCAVATION OF TEESTA VI HYDROELECTRIC PROJECT (500MW), SIKKIM, INDIA.

ANIL KUMAR DASH¹, MANOJ KUMAR LAKRA², SAIENDRA SINGH BARIHA³, MOHINDER PAL SINGH⁴, ANOOP KUMAR PATEL⁵

¹ NHPC Limited (A Govt. of India Enterprise), India, akdash@nhpc.nic.in

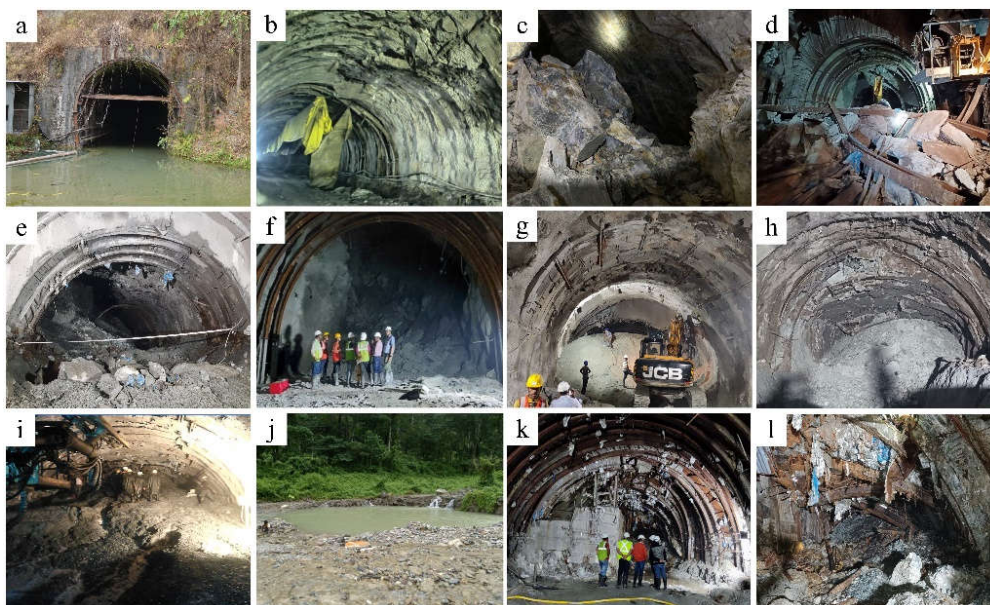
- Without any dewatering arrangement, Adit-1, 2 & 3 were flooded with seepage water and further access to HRTs were blocked.
- HRT Faces 0A and 0B from Adit-1 were in collapsed state due to encounterance of crushed quartzite in the form of sugar cube and bands of sheared Phyllite.

- HRT Faces 1A & 1B from Adit-1 and Faces 2A & 2B from Adit-2 were in fairly good condition except some areas where Ribs and LGs were either twisted, deteriorated or cracked, wire mesh and shotcrete were detached and rock mass at crown areas were exposed.

- A big cavity was formed at 400m inside Adit-2 during restoration works due to prolonged exposure of rock mass to saturation conditions.
- HRT Faces 3A & 3B from Adit-2 and passing below Kalej Khola were in completely collapsed state. Furthermore, a surface cave-in was observed on the surface above face-3A.

- The already excavated tunnel behind HRT Face 4A and 4B from Adit-3 were collapsed due to encounterance of highly weathered and sheared Phyllite. Further, the reported incidence of a surface cave-in had compelled fear among the local public. Also, downstream Faces 5A & 5B of HRTs from this Adit had encountered a maximum number of collapses/cavities formations at various locations especially where Steel rib support was not provided.

- From Adit-4A two faces Face 7A & 7B were already excavated and partial lining work was also completed. But the upstream faces 6A and 6B were partially excavated and Face 6A was in a collapsed state 100m behind the Face.

Figure 3. Showing Photographs of Hindrances faced during resumption of Underground works. (a) Water accumulation at Tunnels. (b) Twisting and Buckling in Lattice girder. (c) & (d) Rockfall and cavity formation in already excavated tunnel portion (e), (f), (g) & (h) huge cavities and collapsed tunnel area in already excavated tunnel portion. (i) & (j) Collapsed tunnel face and surface cave-in above the tunnel at Kalej Khola (k) & (l) Collapsed tunnel below Kamlet Khola.

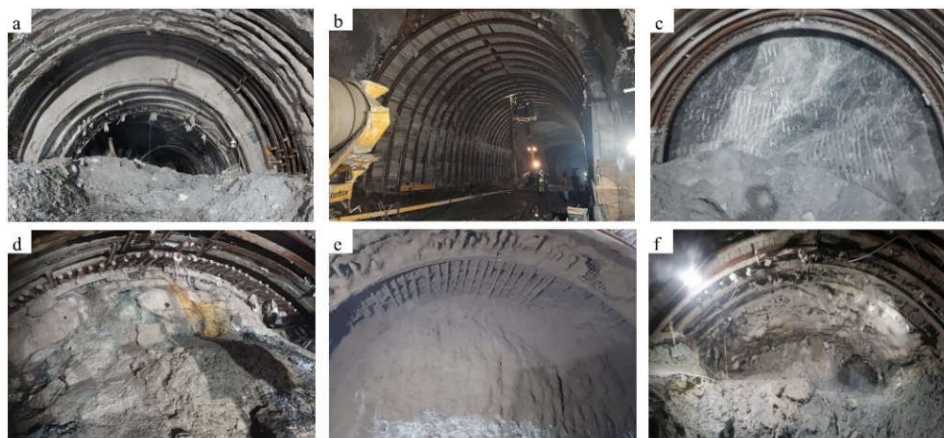
Figure 5. Showing Photographs of rectification works and additional support measures (a) restoration work under progress, skin to skin ribs were embedded under SFRS (b) Rectified tunnel (c) Fore poling to stabilise the crown of the Tunnel. (d) & (e) Pipe roofing created an umbrella-like structure above the crown to prevent collapses. (f) Multisegmental excavation.

During construction by the previous developer, primary support in the form of shotcrete, rock bolts, dominantly Lattice Girder etc. were provided in HRTs / Adits that had the initial support for the opening. Consequently, many stretches of the already excavated HRTs by previous developer had developed with age various defects like chipping out of shotcrete, distressing in rock bolts, buckling of LG / Ribs, distortion of the tunnel cross section which has been associated with huge cavity / cone formation. Accordingly, more than 300 working days have been consumed for additional restoration and strengthening measures for most of the already excavated portion of the HRTs to avoid threat of further instability which has facilitated advancement in excavation from established faces. The additional protection measures included application of Steel Fibre Reinforced Shotcrete (SFRS) and anchored rock bolts and replacement of buckled LG/Steel ribs with new ones. Bracing support through MS beam / plate along with additional Rock bolts/ Self-Drilling Anchor (SDA) were provided which was completely embedded with fibre shotcrete. Afterward, extensive grouting activities were carried out on potentially vulnerable zones for consolidating the poor rock mass behind the rib supports.

Specialised manpower were deployed for specialised works like pipe roofing, grouting activities etc. Pipe roofing was carried out with 21 m long, 89mm dia pipes @ 15-20 degree with an overlap of 10m length.

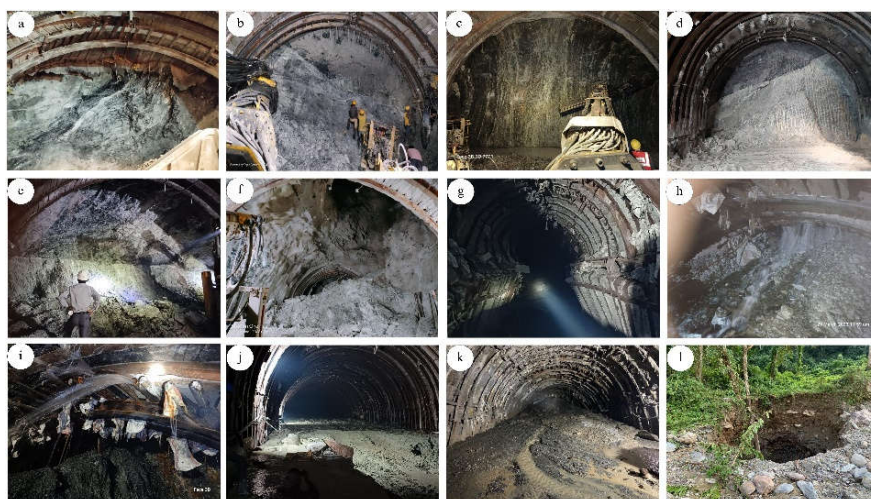
Figure 6. Showing Photographs of Geological hindrances faced during fresh excavation (a) Shear seams Parallel to foliation plane. (b) Shear zone at the hinge of synclinal fold. (c) vertical Shear seams at the hinge of Anticlinal fold. (d) & (e) Shear zones manifested along Fault planes. (f) Cone formation due to subparallel foliation plane (g) Squeezing in the tunnel. (h) & (i) Flowing water condition. (j) Tunnel filled with slush (k) & (l) Collapsed tunnel face & Surface Cave-in above the tunnel face.

These geological features are associated with multiple shear seams of varying thickness from few cm to tens of metres had continuously hampered the tunnelling activities to a greater extent. The rock mass along these shear seams/zones are strongly deformed, crushed, cohesionless and showing substantial heterogeneity. Encountering these shear zones during tunnelling results in the form of face instability/collapse, excessive over break, cavity/chimney formation, running ground condition, mud inrush, squeezing and/or swelling of rock mass etc. Tunnelling through this type of shear zone was extremely challenging and difficult which required additional support measures in the form of pregrouting, pipe roofing, fore poling along with steel ribs support were completely embedded in SFRS.
