DESIGN AND CONSTRUCTION FOR REHABILITATION OF EARTHQUAKE DAMAGED WATER PROTECTION LEVEES - METHODOLOGY AND SOLUTIONS

IVAN MIHALJEVIĆ¹, BERISLAV RUPČIĆ¹, MARKO KAIĆ¹, GORAN GRGET¹, LEO MATEŠIĆ¹

¹ Geokon-Zagreb d.d., Croatia, info@geokon.hr

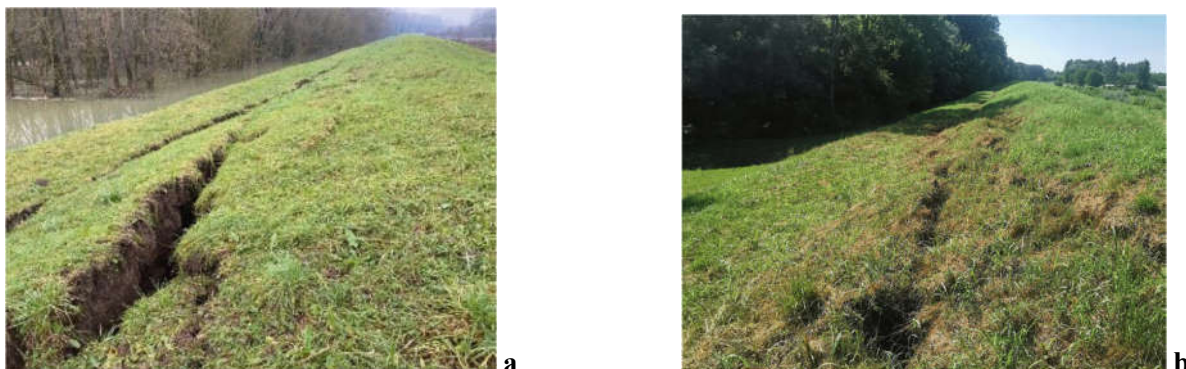
Contracts with designers were concluded six months after the earthquake. In order to gain insight into levee damage, recordings and observations carried out by experts and volunteers in the days immediately after the earthquake, when there are traces of liquefaction and cracks in the soil and levees were "fresh" (Fig. 1a), proved to be invaluable. Subsequently, many cracks in the soil self-healed, or were hidden with grass growth by the time of designing, while traces of liquefaction have been washed away (Fig. 1b).

Figure 1. Comparison of the levee crack: a) immediately after the earthquake and b) after 6 months

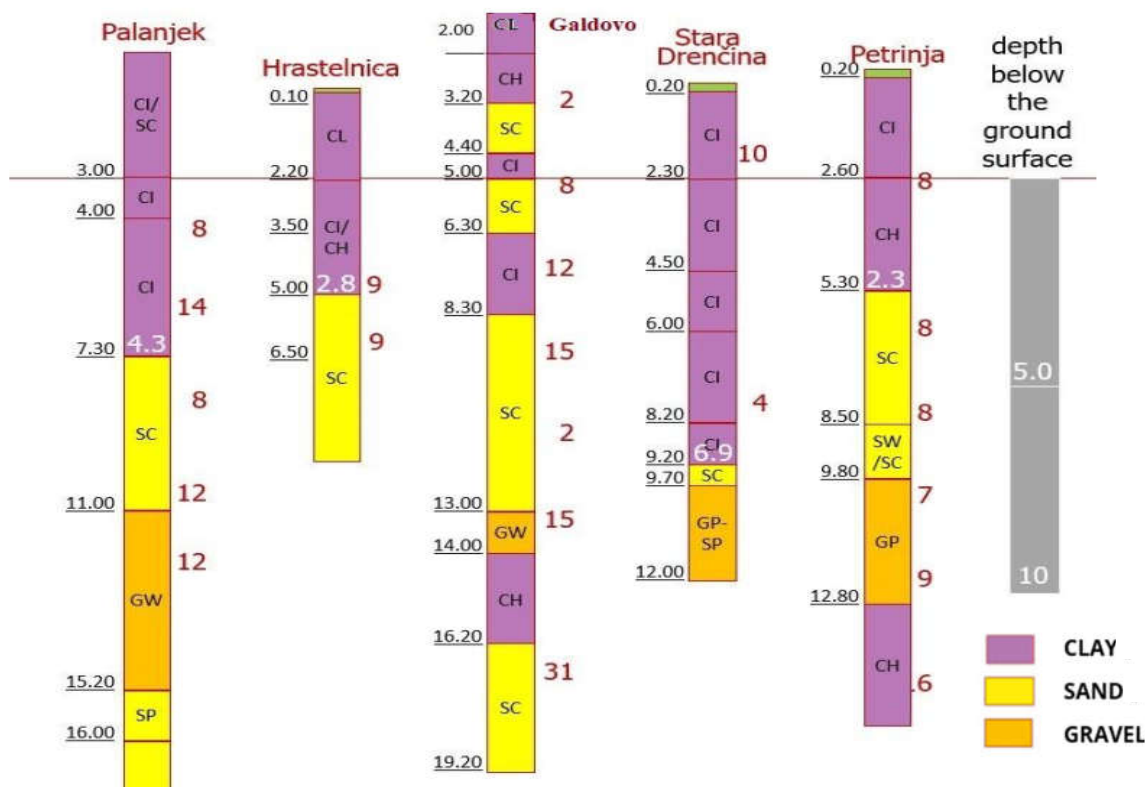
The geotechnical stratification of the underlying soil and the physical and mechanical parameters of the material were determined by exploratory boreholes. Special emphasis was placed on performing a larger number of static penetration tests (CPT), given that the determination of liquefaction potential relied on CPT tests (Boulanger and Idriss, 2014). Geophysical measurements were carried out with the aim of determining the thickness of the roof clay layer along the levee. Geophysical methods of seismic refraction, MASW (multichannel analysis of surface waves) and geoelectrical tomography were applied. In most locations, the composition of the foundation soil was determined, which consisted of roof clay layer and sand and gravel underneath (Figure 2).

Figure 2. Geotechnical layering of embankment and subsoil by depth at damage locations with SPT values (according to Mihaljević and Zlatović, 2023)

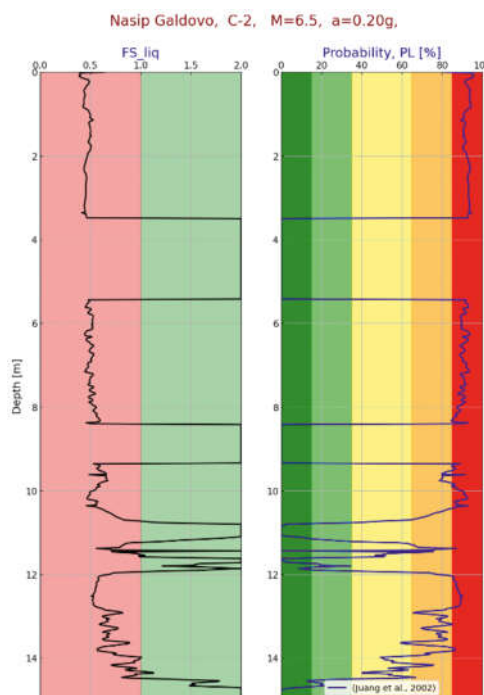
Figure 3. Safety factor against liquefaction and probability of liquefaction occurrence (Galdovo)

The analysis of the liquefaction potential at the locations of the damaged embankments was carried out according to the results of field CPTU tests, for an earthquake of magnitude M_w 6.5, with an assumed high level of underground water (Fig.3).

The results at the locations of most of the damaged embankments showed a high potential for the occurrence of liquefaction.

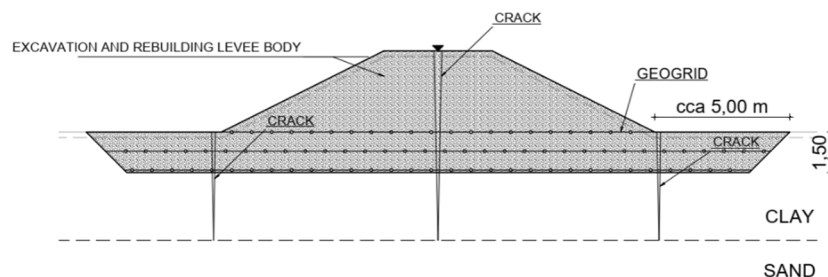
A special challenge was represented by longitudinal, deep cracks along the toe of the embankment, which partially collapsed and self-healed after a certain time after the earthquake. The question arose whether it is necessary to treat them and in what way. It was concluded that they represent a permanent problem as places of possible seepage and internal erosion under the levee, and that they must be rehabilitated in the zone immediately next to the toe of the levee.

The limiting factor in the projects was the investor's request that the rehabilitation be carried out within the geometry of the existing levee and in the width of the existing cadastral parcels of the levee. The chosen solution for levee that developed cracks and deformations and lost their integrity consisted of partial or complete removal of the clay embankment body and its reconstruction in the geometry that existed before the earthquake, while reinforcing the levee body by installing layers of geogrids (Sasaki et al., 2004).

It was decided to excavate the foundation soil in the areas of the cracks near the toe of the levee to a minimum depth of 1.5 m and to install the clay material in a controlled manner, in order to ensure continuation of the soil conditions and safety from the hydraulic uplift.

Figure 4. Solution for the repair of cracks and strengthening of levee against seismic loads

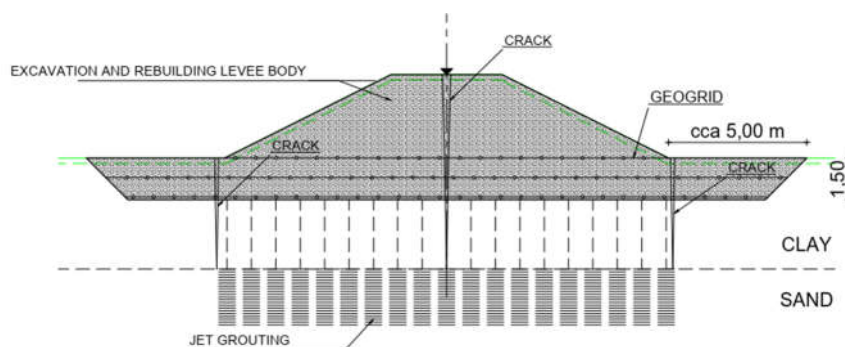
The results of the investigation showed that the underlying soil under the levee, even after the appearance of liquefaction in the past earthquake, is susceptible to liquefaction for new seismic actions and it is necessary to strengthen it.

On the parts of the levees that have experienced subsidence due to liquefaction, the foundation soil in the zone of the sand layer has been rehabilitated with a grid of jet-grouting columns, which have the role of increasing the resistance of the layer to seismic cyclic loading and, in the event of liquefaction, transfer the loads from the embankment and the overlying layer, as shown in Figure 5.

Figure 5. The solution for strengthening the sand layer under the levee with jet-grouting columns

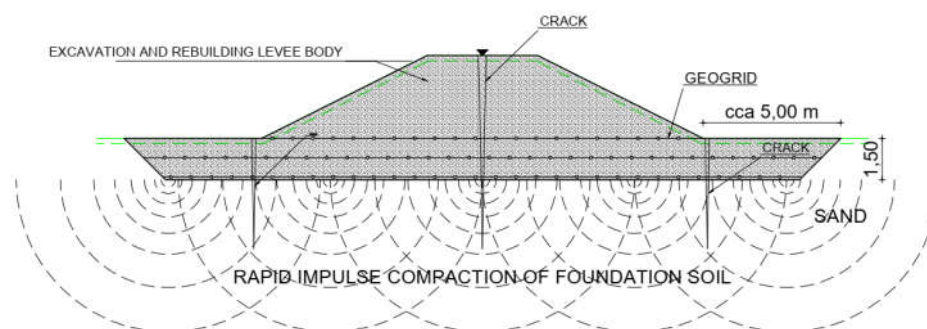
Control of the improvement by pulse compaction in terms of resistance to liquefaction is carried out by CPTU tests before and after the reclamation of the base soil. Although some limiting factors occurred during rehabilitation works (high water levels of river Sava resulting in high ground water levels) results showed that liquefaction potential has been significantly reduced.

On the section of the damaged Sava levee near Galdovo, where the underlying soil is sandy, the improvement of the underlying soil by impulse compaction (rapid impact compaction - RIC) was chosen, as illustrated in Figure 6. With this improvement method the soil is compacted and brought to a denser state by a machine that strikes the surface of the foundation soil dozens of times per minute with a weight over a transfer plate. RIC was chosen because of its applicability to increase the density of granular soils and thereby reduce the likelihood of liquefaction.

Figure 6. The solution of strengthening the sand layer under the levee by impulse compaction
