REMEDICATION OF THE EARTHQUAKE - INDUCED COLLAPSE SINKHOLES IN SISAK – MOSLAVINA COUNTY

Abstract

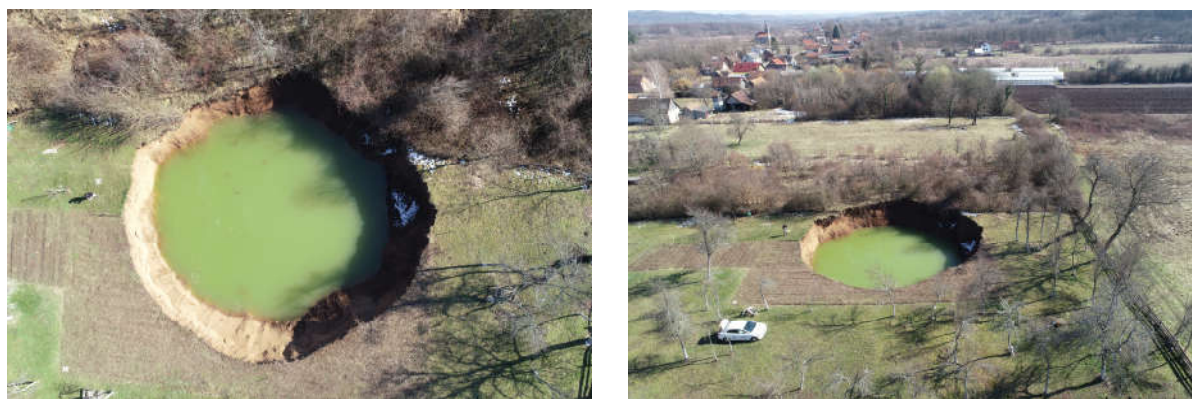
This paper focuses on the rapid assessment activities carried out in sinkhole occurrence area, which led to sinkhole categorization and served as a starting point for the development of the remediation design and the implementation of the remediation measures. While the general assessment methodology is explained, the planning and remediation design and work is demonstrated using the example of the largest collapse sinkhole (UVM-001) with a diameter of 25 m and a depth of 13 m (Figure 2).

Figure 2. Largest sinkhole (UVM-001) occurred as a consequence of the Petrinja 2020 earthquake

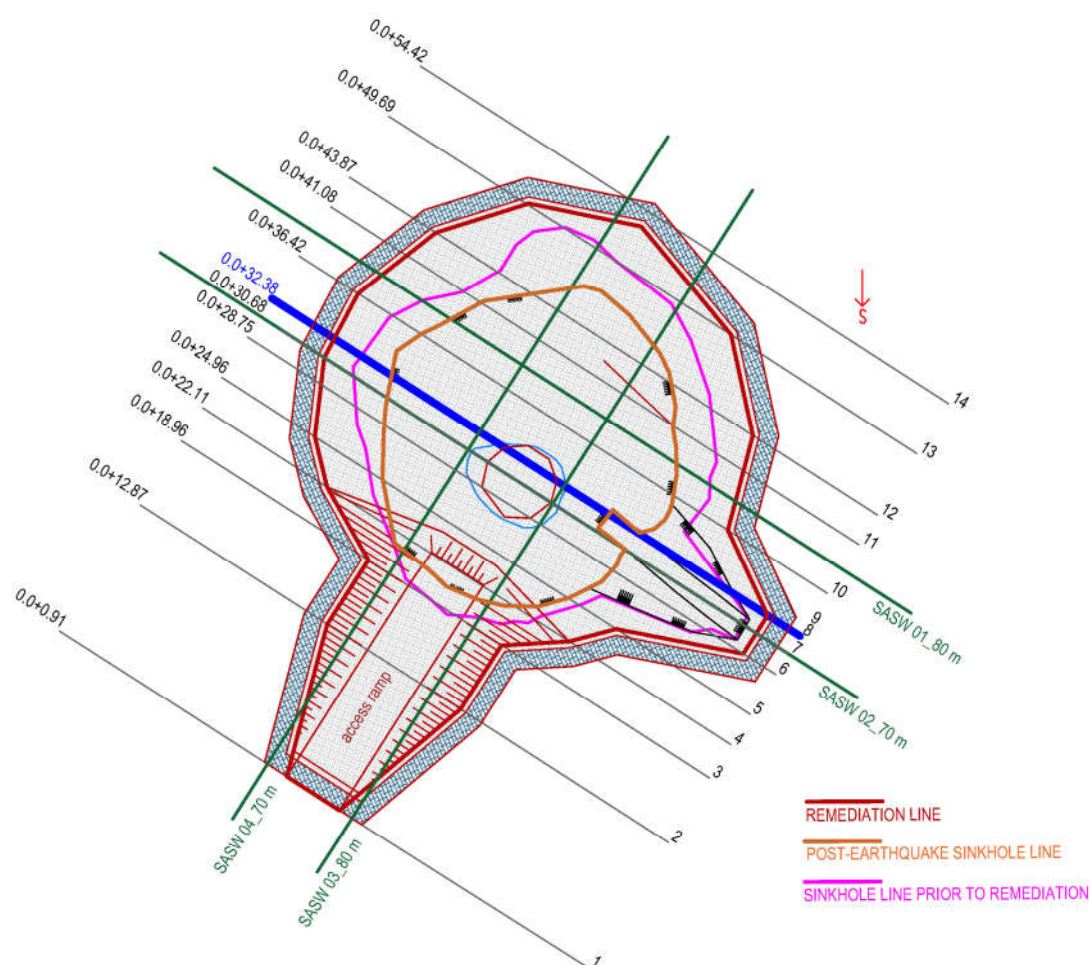
Figure 6. A layout of the remediation solution for UVM-001, modified from Brodska Posavina (2023)

The remediation layout is given in Figure 6. The method consists of backfilling a sinkhole, including blocking the sinkhole throat with boulders, followed by the installation of upper granular layers with high permeability, each with finer particles than the one below. The backfill material consists of 300 -

500 mm and 500 – 800 mm boulders (Type 1), followed by 32 – 250 mm crushed stone (Type 2), over which 16 - 32 mm material (Type 3) is placed. The Type 2 and Type 3 materials are placed in 50 cm thick layers and compacted to 40 MPa.

After the initial excavation and reprofiling of the slopes, due to removal of loose slope material and to achieve sufficient compaction of the backfill material, the excavation area is lined with a geocomposite consisting of a non-woven geotextile with a mass of 300 g/m^2 (to prevent the penetration of fine soil particles into the backfill material during the water seepage) and biaxial geogrids with a tensile strength of $30/30 \text{ kN/m}$ (to allow interlocking with the backfill material, increasing both the stiffness of the backfill and the contact shear strength along the slope). The geocomposite is placed in the surface trench and anchored to the ground with U-segments of reinforcing steel. The geogrids were also positioned at predefined heights to enable interlocking with the backfill material.

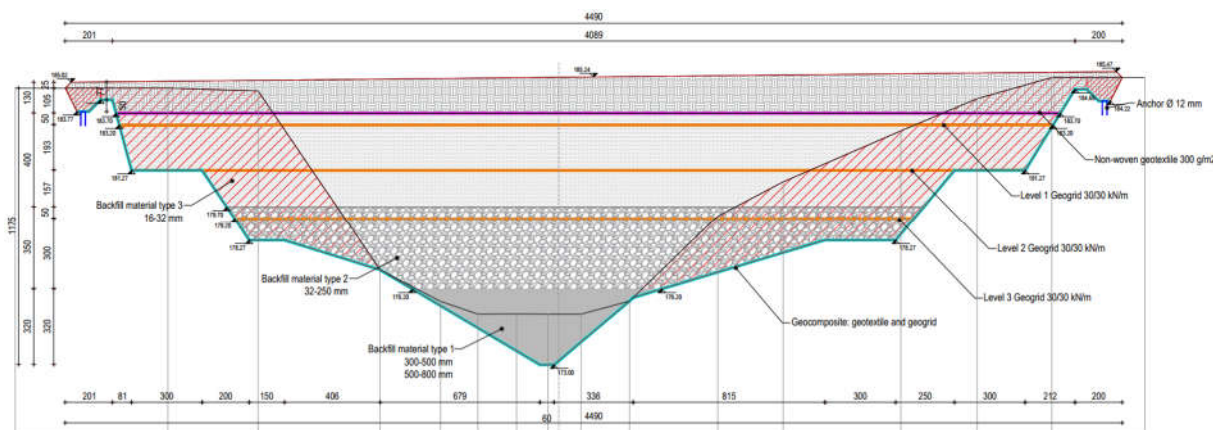
Figure 7. A cross-section of the remediation solution for UVM-001, modified from Brodska Posavina (2023)

After backfilling the surface opening, the top layer of clay is installed in four 25 cm thick layers at a thickness of 1.0 m (on agricultural fields) or 0.5 m (on non-agricultural fields) and the surface is then weeded. The separating geotextile is laid on type 3 – clay cap boundary. The characteristic cross-section (blue line from Figure 6) is given on Figure 7.

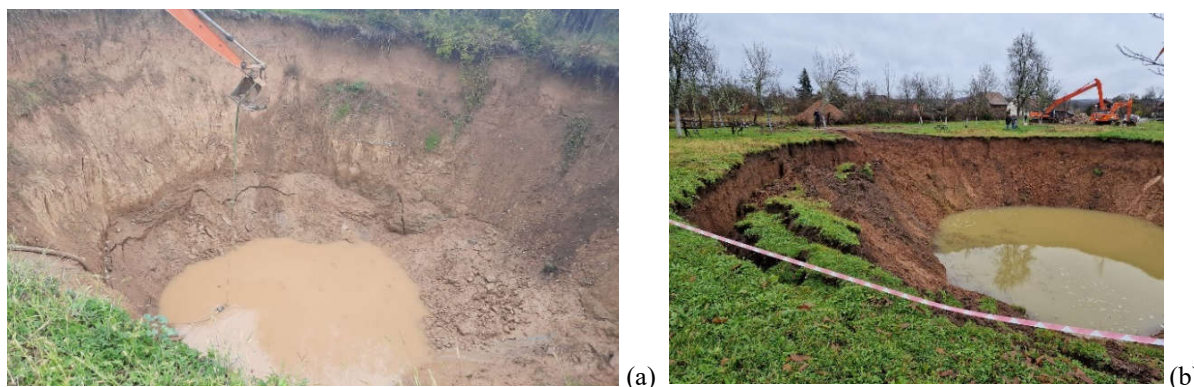
Due to its size (almost 50% of the volume of all the collapse sinkholes in the area) and complexity, the majority of the remediation work was focused on the largest collapse sinkhole, UVM-001. In order to carry out the planned work, the contractor started a trial water pumping operation to verify that the work could be carried out in dry conditions. It was found that water ingress was quite low due to the low permeability soil deposits. However, during this work, cracks appeared in the bottom of the sinkhole slopes and eventually slope sliding occurred, most likely due to the residual water in the soil reducing the shear strength and the loss of external water pressure, Figure 8. Slope sliding-induced sinkhole enlargement is depicted on Figure 6, compared to its initial size recorded just after the earthquake.

Figure 8. Trial pumping of sinkhole water (a) and the consequent collapse of the sinkhole slopes (b)

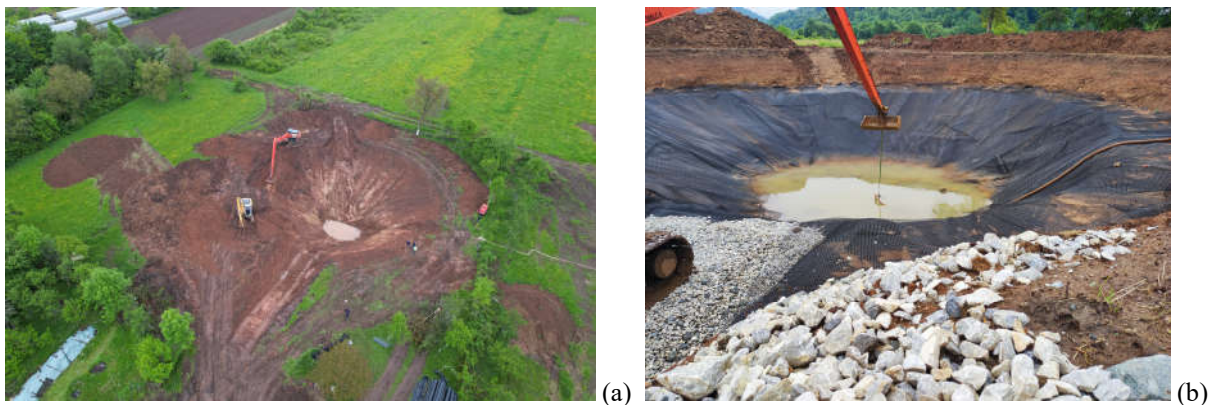
Figure 9. Reprofiling of the sinkhole slopes (a) and installed geocomposite on the excavation area (b)

Work on the largest sinkhole began with the slope reprofiling (Figure 9a) in May 2023 and was completed in July 2023. However, it should be noted that the preparatory work started earlier, as the access road for the heavy machinery had to be built, as well the temporary disposal areas for the backfill material and geosynthetics. In addition, the underground telecommunications cable that runs along the site had to be relocated. After the geocomposite was installed (Figure 9b), backfilling began with Type 1 material (boulders), followed by Type 2 and Type 3 material (Figure 10).

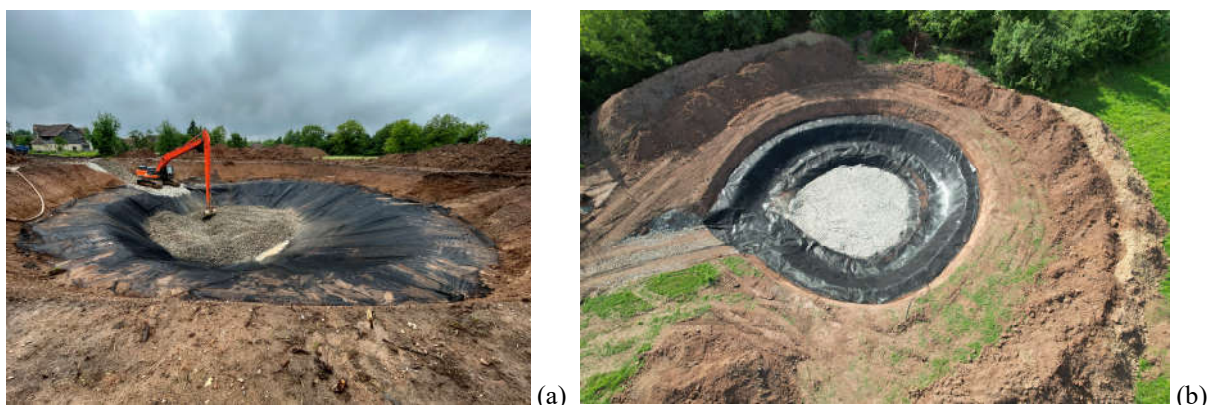
Figure 10. Backfilling works using long reach excavator (a) and aerial view of material type 2 placed and compacted (b)

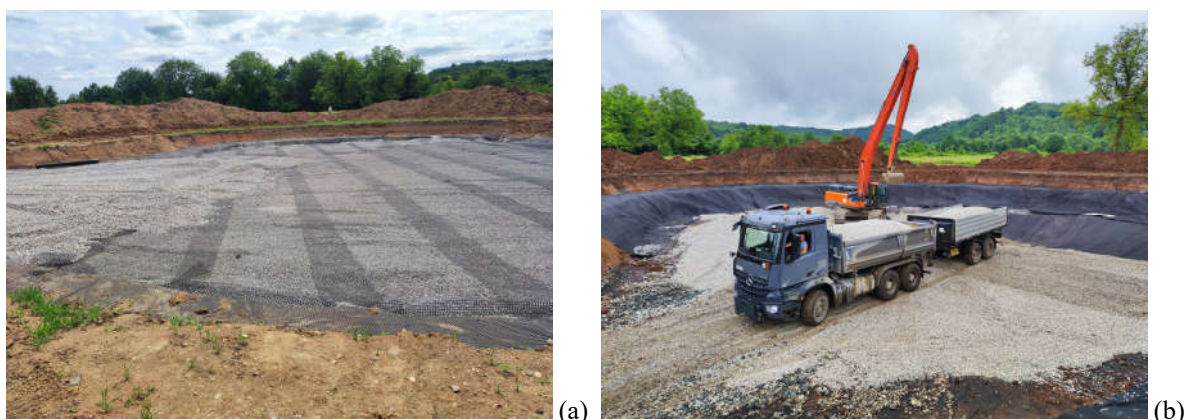
Figure 11. Installed biaxial geogrids (a) and heavy machinery inside the sinkhole (b)

During the backfilling work, several heavy rainfall events occurred, which prolonged and made the remediation work more difficult. However, the combination of the compaction of the backfill material and the installation of geogrids (Figure 11a) provided a solid foundation for the work of the heavy machinery (Figure 11b). This can be also considered as a large-scale load test which verified design solutions since no problems occurred regarding excessive deformation or settlements of backfill material. Finally, a clay cap was installed (Figure 12a).

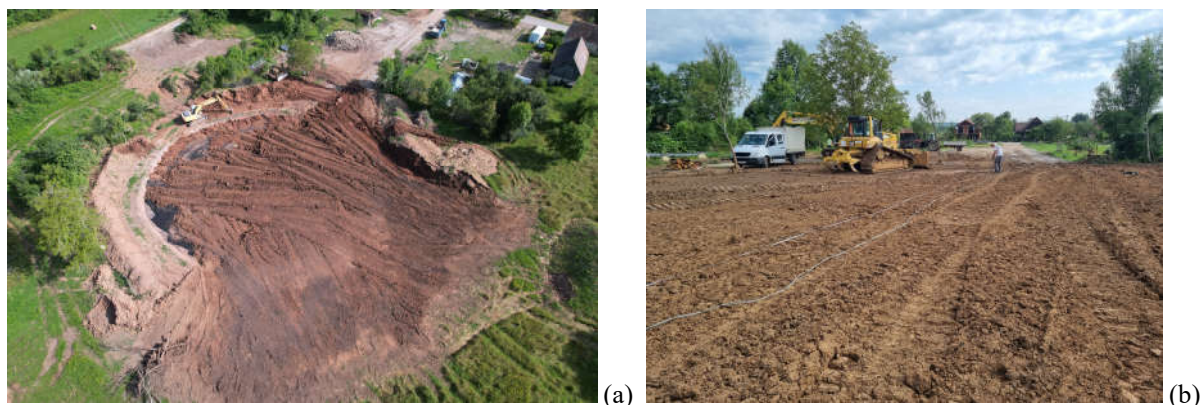
Figure 12. Installation of final layer of clay cap (a) and the terrain surface after the remediation works with SASW control quality work being conducted (right)

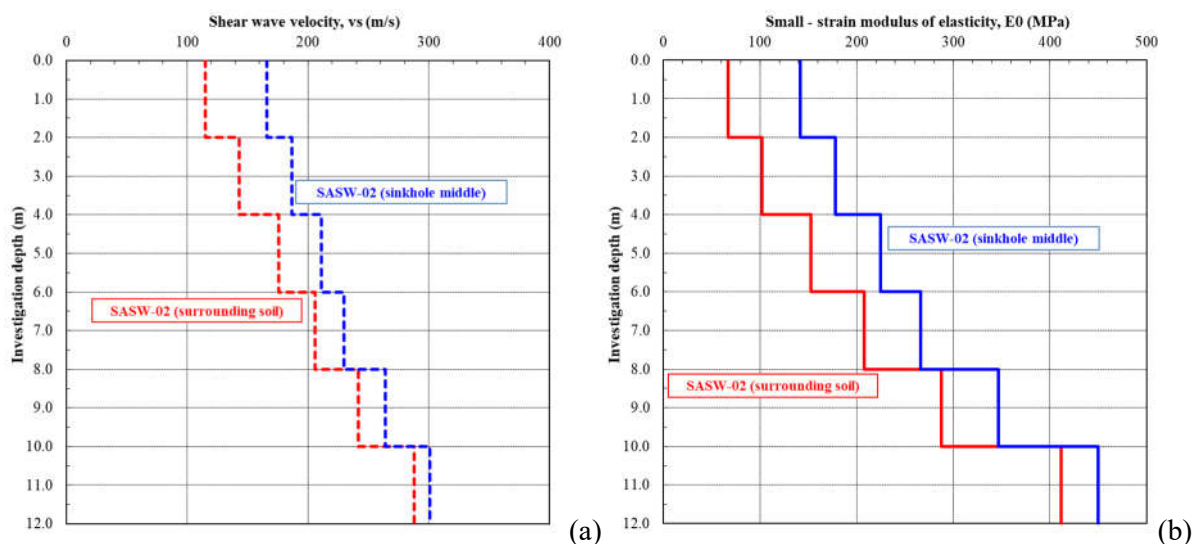
Continuous supervision and control quality works have been carried out during the sinkhole remediation, which was particularly important given the many remediation phases and the large number of details. All the materials installed complied with the criteria set by the design. Quality control works were also carried out, including the plate load test to check the compaction of each layer and the geophysical method of spectral analysis of surface waves (SASW) to determine the stiffness over the entire backfill depth at the end of the work. Results of the one SASW profile, named SASW-02 (Figure 6), are shown in Figure 13. The required small – strain stiffness is higher than required by the design. It can be also seen that the backfill material (blue lines) exhibits larger shear wave velocities and small - strain stiffnesses than the surrounding soil (red lines) which is characterized by overconsolidated clayey materials. The monitoring network consisting of survey points was installed to measure the long-term settlement of the backfill material and this monitoring work will continue in the near future.

Figure 13. Excerpt from results of one SASW profile showing shear wave velocities (a) and small – strain stiffnesses (b) of the backfill material and the overconsolidated surrounding clayey material (CFCE, 2023)
