GEOHARZARDS TRAPS ENCOUNTERED ON THE ROUTE OF THE HIGHWAY PITEŞTI-SIBIU, ROMANIA

MIHAELA STĂNCIUCU¹, ADRIAN M. DIACONU², IULIANA G. DOGARU², RAMONA A. MIHAI²

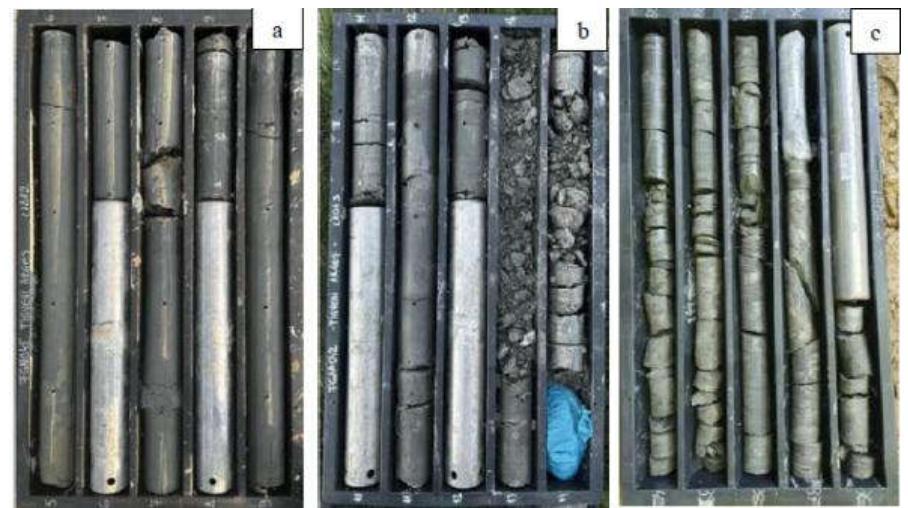
The bedrock formations, regardless of petrography / lithology or age, is found in boreholes with the specific characteristics of an overconsolidated rock, intensely fragmented by relaxation and sometimes with one or more intense shearing intervals. This situation may explain by the fact that in this specified area, all bedrocks formations were and still are subject to the following fields of efforts (Figure 2 a, b, c):

Figure 3. Aspects of hazadous geologic characteristics of cohesive bedrock: (a) undisturbed; (b) sheared ; (c) intensely fragmented by relaxation Pucioasa formations(*ch-aq*);

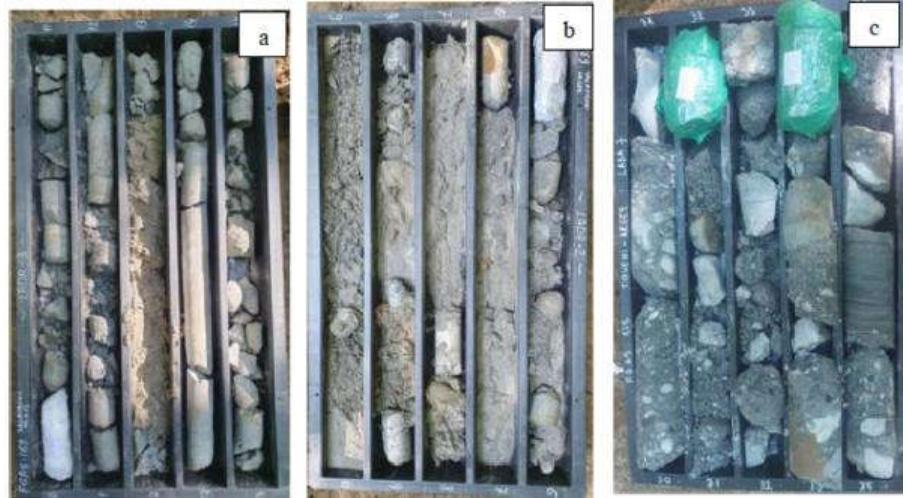
Figure 4. Aspects of hazadous geologic characteristics of un-cohesive bedrock:
(a) Variable degree of cementation of sandstone; (b) immersed sands and fragments of Eocene sanstone (*Pg*₂);
(c)) *"erratic*" polygenic conglomerates with variable degree of cementation (*aq-bd*)

Most of the time, the non-cohesive bedrock deposits are either fine and very homogeneous or coarse and extremely inhomogeneous, containing numerous rock fragments of various sizes and petrographic types. In many positions the fine - non-cohesive deposits are found in a partially/apparently cemented state (Figure 4, a), generating levels of sandstone with cementing levels ranging from uncementing to very well cemented. But there are also situations where these deposits contain intercalations of conglomerates, core samples with lengths >0.50m of compact rocks or fragments of hard rocks which are more or less desegregated (disaggregated?) (Figure 4, c).

the natural sedimentary structure and leave the volume of the affected slope with near nul shear resistance. As mark of this geomechanical process, we found in boreholes, in both formations frequently "immersed sands", as presented in Figure 4. b.

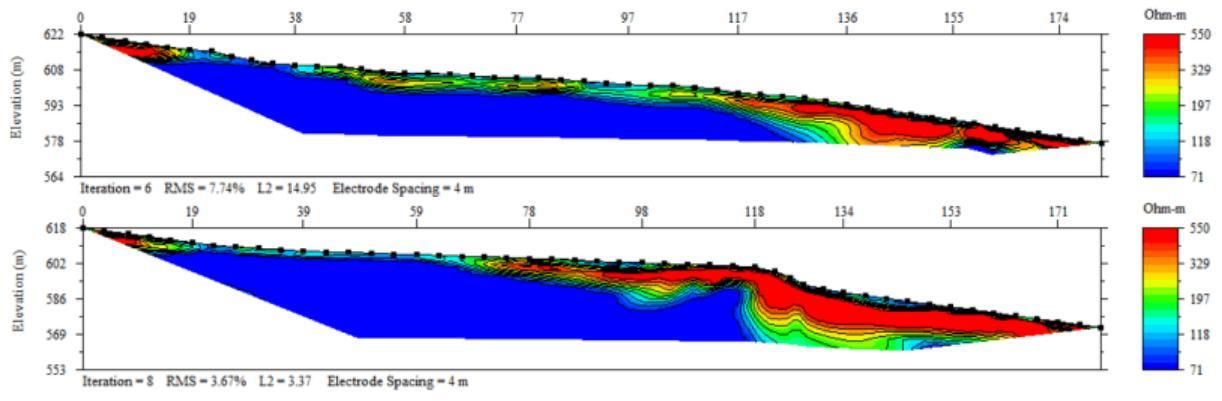
Due to the limited and discontinuous extensions of these suspended aquifers, displacements do not generate a well-defined area of yielding, however, it is very likely that this fact is one of the primary causes of multiple lithological disturbances and discontinuities of the non-cohesive deposits that subject the slopes constantly and continuously to some "incremental" displacement downstream, over short distances. These cumulative manifestations over time, or amplified by seismic events (that may generate even local liquefaction areas) can lead to significant instability as is confirmed by geophysical investigations executed in these areas, two of them being presented in Figure 5.

Figure 5. Geophysical investigations (*ERT*) wich confirm the instability of deluvial shallow deposits (Geotesting C.I, 2023)

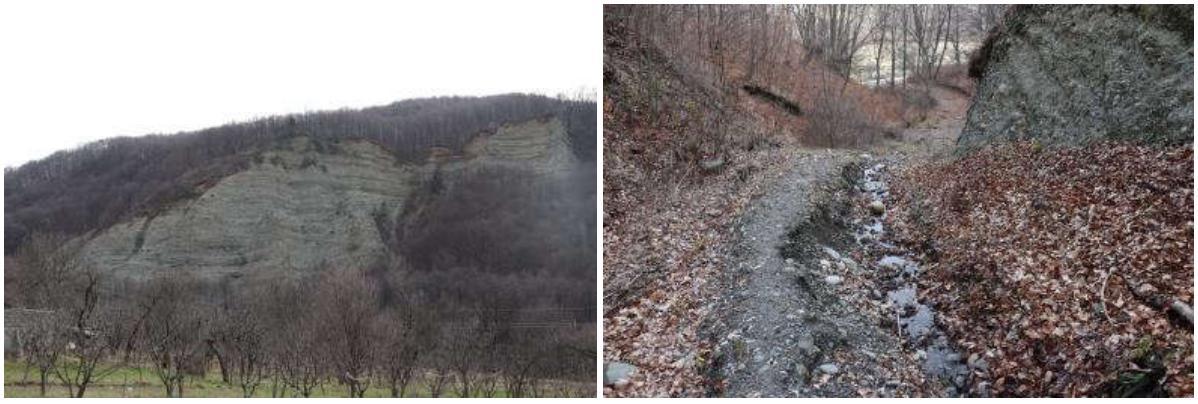
- finally, we mention here, as an important anthropic hazard, the presence of the exploitation career of sand and gravel in Salatrucu, Arges County, which is subjected to continuous regressive erosion processes under the action of rainwater, accentuated on the background of poor cementing of conglomerate formations (Figure 7).

Figure 7. Aspects of the perimeter of the exploitation of sand and gravel quarry in Salatrucu

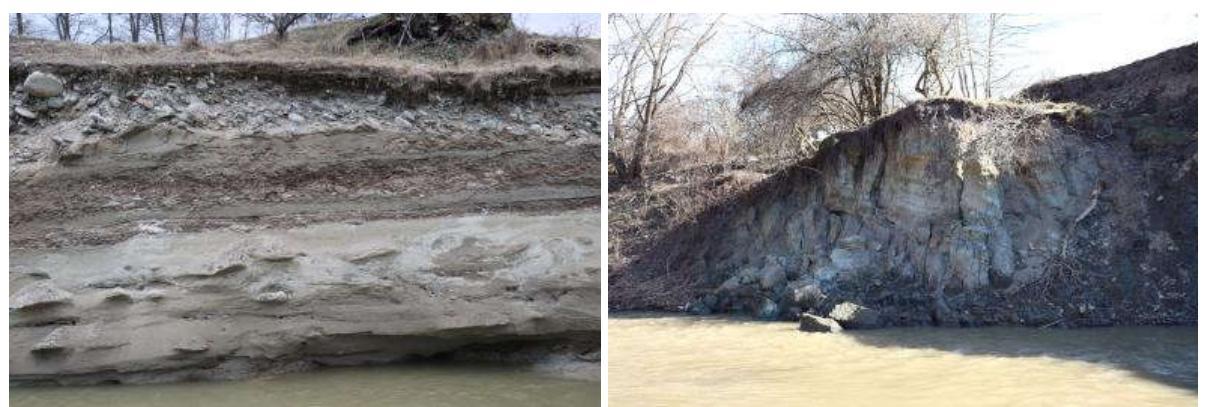
- erosional processes of alluvial banks, which is active along the entire length (Figure 8);
- fewer torrential valleys affluents on the left that discharges the waters coming from the surface of the terrain and water leakages on the forehead of the alluvial plain. In one position, namely Vãleni location, it develops a limited area of terraced deposits that are shattered by an important left affluent;
- some instability phenomena at the level of connection between the minor and the major riverbed;
- finally, an important anthropic hazard on this side represents the presence of numerous and extensive bumps (positive and negative) due to chaotic exploitation of alluvial deposits or landfills, as the presence of a small concrete dam.

Figure 8. Undisturbed (left) and instable deposits (right) of riverbanks

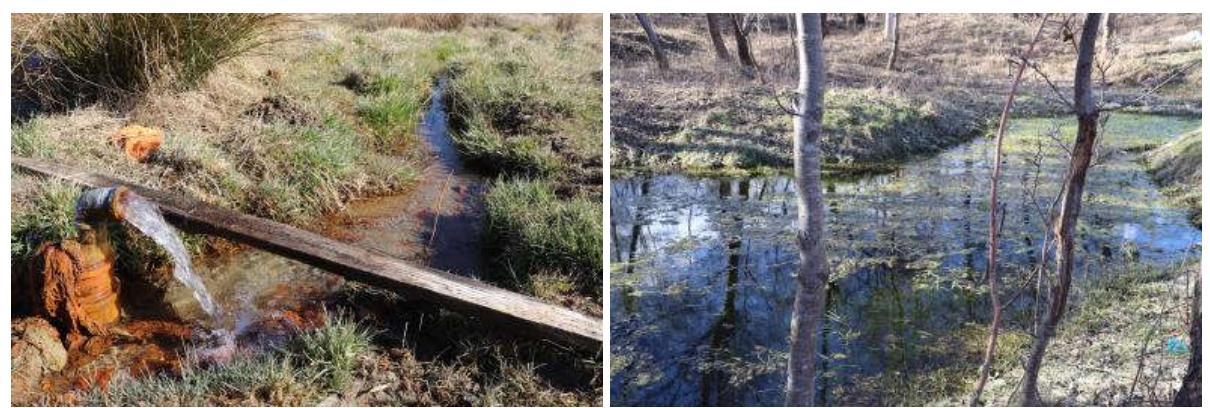
This regional hydrogeological configuration is in hydraulic contact with deeper regional aquifers and can develop water pressures on the coatings up to 40 Barr. The entire package of multilayer aquifers (from the Jurassic to the Upper Pleistocene) operates under a pressure regime that becomes uneven artesian. These deep (regional) aquifer horizons defined as the "Dacian Artesian Basin", is located under the erosion base and is supplied by infiltration of the surface waters of the main valleys and atmospheric precipitation through the border areas of these formations, which sometimes are situated far away. In consequence, all these structures are therefore in hydraulic communication with the groundwater levels

generating vertical drainage phenomena when the developmental pressures are high (Figure 9).

Figure 9. Artezian well and swamping areas created by vertical ascensional drainage of Cândești aquifer

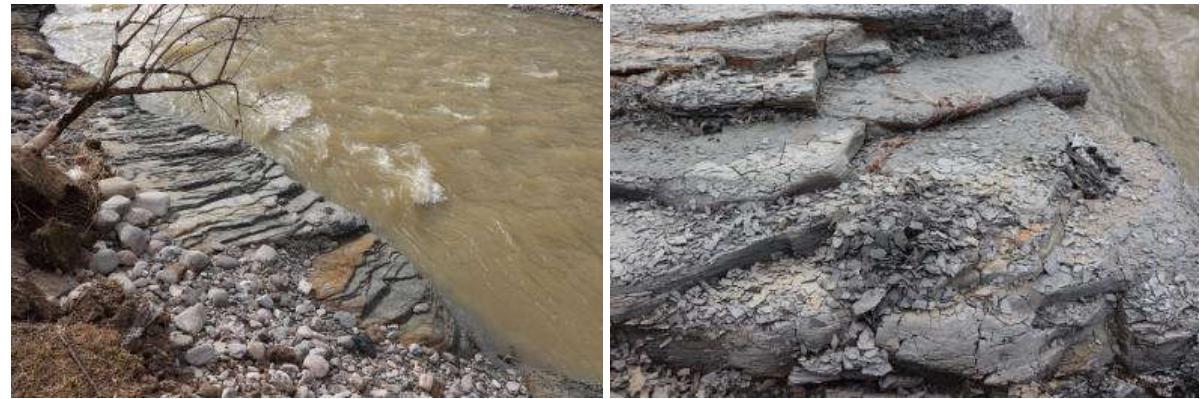
On this Southern part of the project, the foundation ground consists mainly of weakly consolidated or normally consolidated alluvial quaternary formations (maximum 15m thick), followed in depth by bedrock formations which include alternations of cohesive and non-cohesive complexes (Figure 10). The main risk factor is the quasi-continuous presence of soils with large swelling and contractions, both in the case of bedrock formations framed in the cohesive complex and sporadically in the fine-cohesive levels of the quaternary deposits. An extensive study of these swelling formations was based on more than 660 samples that have been tested both mineralogical and geotechnical.

Figure 10. Cohesive bedrock in the Sothern part of the project

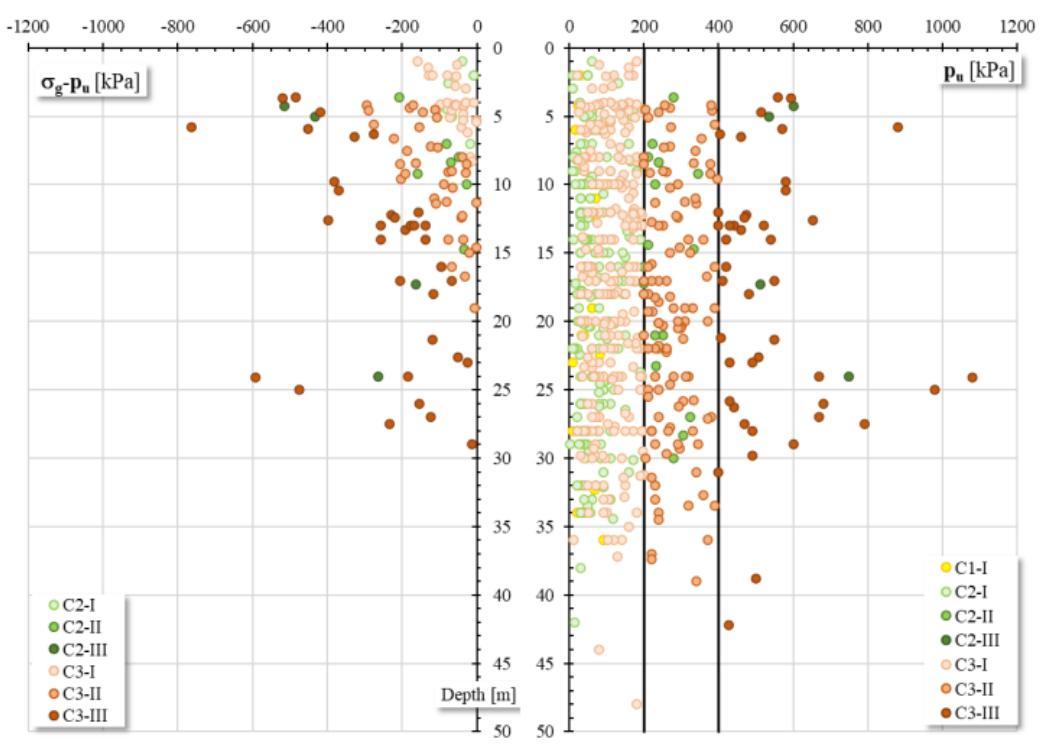
Figure 11 presents the variation in depth of the swelling pressure as the corresponding distribution of differences between inflation pressures and geological load at the level of sampling of the respective sample (p_u-s_g) .

We appreciate that these values must to be regarded as estimative but expressing a real geotechnical risk that can manifest both in the areas specified by this investigation, as well as in the syngenetic areas that have not been tested yet, especially due to the intricate occurrence of these soils in the vicinity or inside the Cândeşti Strata.

Figure 11. The variation in depth of p_u (right) and of the potential heave of Cândești Layers (left).
