## SURFACE DEFORMATION OF THE LANDSLIDE OF HATTARO PASS CAUSED BY THE 2024 NOTO PENINSULA EARTHQUAKE

Noto Peninsula Earthquake, Landslide, Displacement vector analysis, Syncline

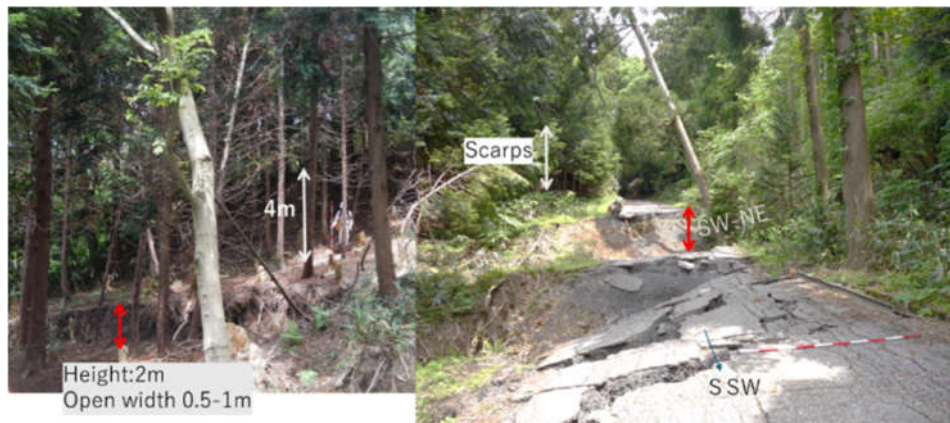
**Figure 7.** Image at Loc. I, showing the southward lowering of a step on the west side of *Hattaro* Pass, which occurred approximately 5 m in front of a small cliff topography (4 m high).

- Loc.I The terrain is a south-falling terrace with a scarps (4 m) behind it (Figure 7).
- Loc.II South-falling terrace crossing a rice paddy field site. The terrain is a south-falling terrain that crosses a paddy field site, suggesting repeated activity. The valley was dammed, and a suitable site for rice paddies was created (Figure 8).
- Loc.III The depression is extensive, reaching a maximum width of 30 m with a step topography of 2.5 m on the north side and 1 m on the south side (Figure 9).

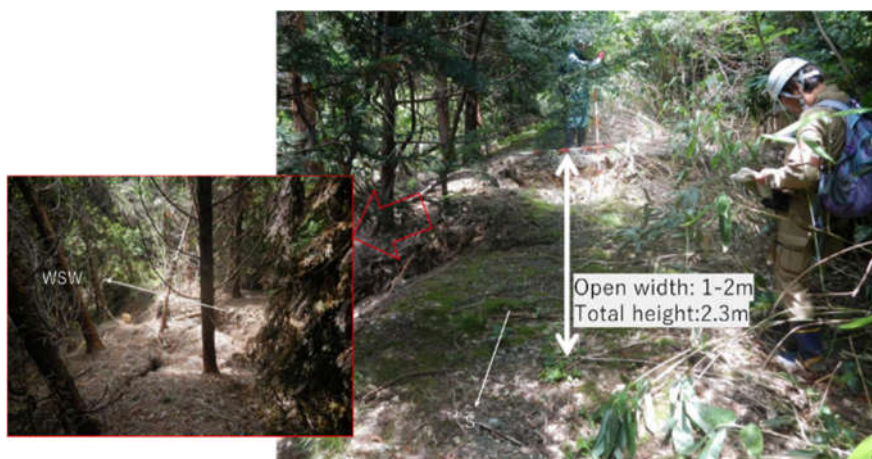
**Figure 10.** Image at Loc. IV. Step-fault like deformation of north side of depression and scarps extending to WNW direction

- Loc.IV Multiple terraces are distributed on the steps in the south-falling terrain. Multiple terraces are distributed on the step, and openings were observed at 0.2–1.0 m on each terrace (Figure 10).
- Loc.V Deformed topography (vertical offset of 1.2 m and right lateral offset of 1.6 m) was observed inside the mobile unit (Figure 11).
- Loc.VI The prefectural road overlooking the Suzuya River was completely collapsed (Figure 12).
- Loc.VII A strange slope extrusion phenomenon was observed in the upper part of the prefectural road (Figure 13).

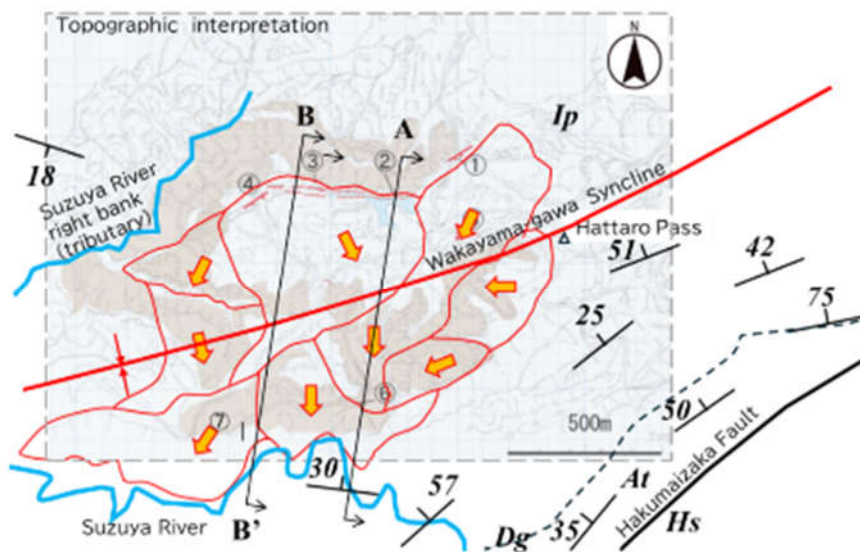
**Figure 14.** Integrated plan, A-A' and B-B' are cross-sectional locations, legends are same as Figure 3, and red thin line is based on the variation area (Figure 6).

Based on the results of the variation vector analysis and survey, the plan, geological structure, and results of the variation vector analysis can be summarized, as shown in Figure 14. The movement trend was significant to the south, orthogonal to the Wakayama-gawa syncline.
